Monitoring Data Record

Project Title: B-3157 (Michael's Branch Site) COE Action ID: 200020843

Stream Name: Michael's Branch

Year 2 Winter – March 2009

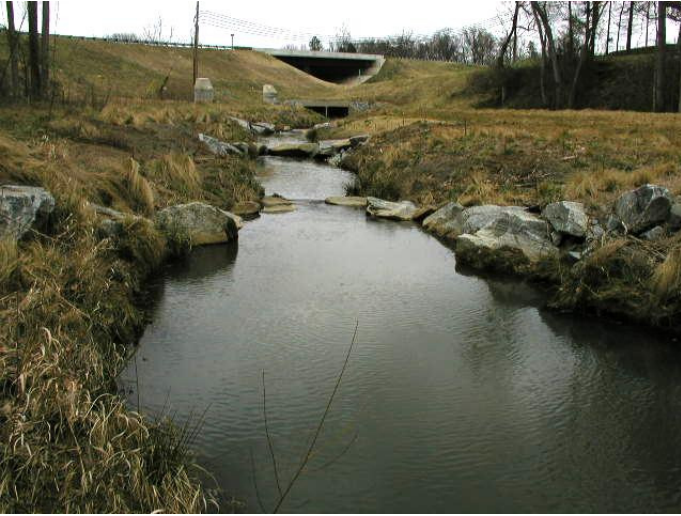
Photo Point #4 (Upstream)

There were dead plantings noted during the 2008 summer evaluation between the outlet end of the double barrel box culvert downstream to PP#4.

Michael's Branch is stabilized for the Year 2 Winter evaluation. The cross vanes up and down stream of Photo Point #4 that were noted during the last evaluation as having some instability have been repaired and are functioning properly at this time. NCDOT will continue to monitor Michael's Branch.

Estimated causes, and proposed/required remedial action: The area noted above was replanted on 1/29/09.
